Amine Gas Sweetening System Problems Arising from Amine Replacement and Solutions to Improve System Performance

N. Hajilary, A. Ehsani Nejad S. Sheikhaei and H. Foroughipour

Process engineering department, South Pars Gas Complex Assaluyeh, Iran

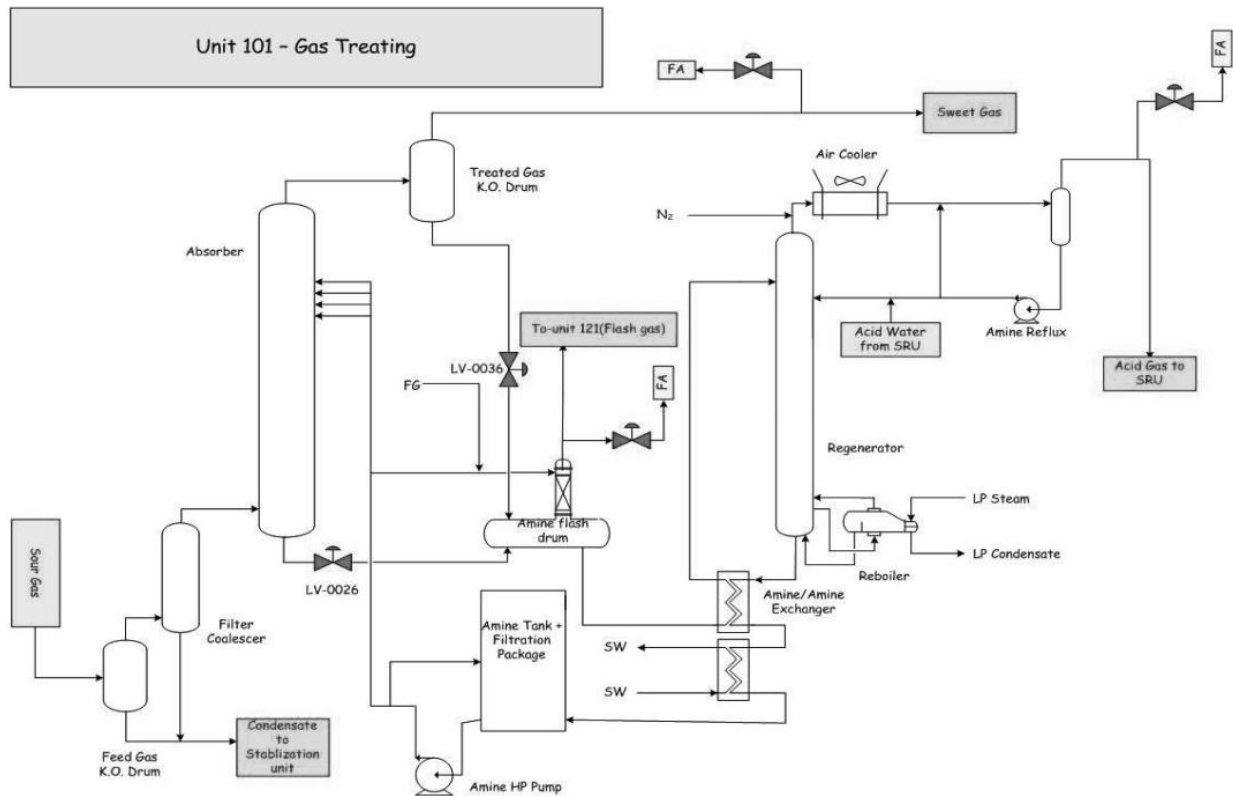
Figure 1- Gas Sweetening Unit.

Amine plant operational problems, such as excessive foaming, intense corrosion and capacity reduction are observed in gas sweetening unit that lead to amine replacement (fig. 1).

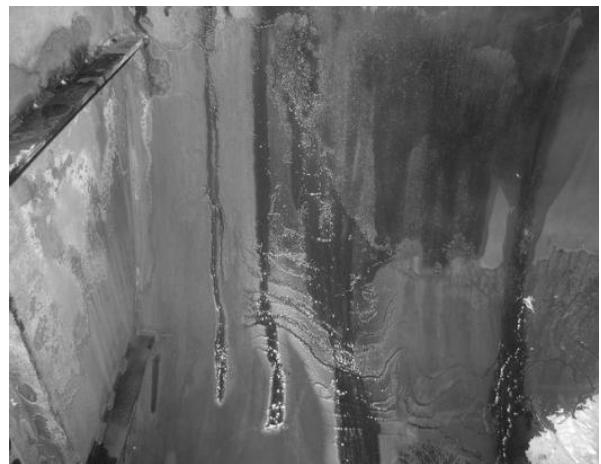
Figure 2- Corrosion sign in reboiler train#1

The major problem with the amine unit was corrosion (fig. 2,3).

According to the inspection report, max corrosion rate of gas sweetening unit was 10.5 mpy in 2009, which was a very high corrosion rate compared with to previous years. It is noted that the refinery’s goal is to keep the corrosion rate below 10 mpy. Some samples were taken from used MDEA. Analysis results for these samples are given in Table 1.

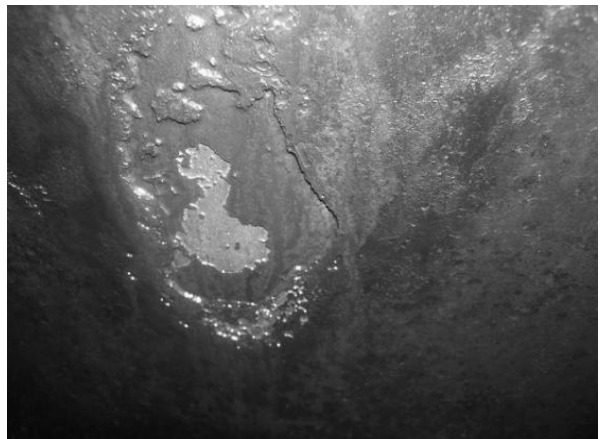
Figure 3- Corrosion sign in reboiler train#2

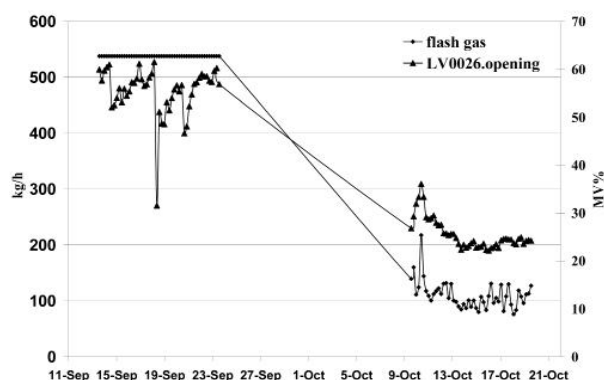
Operation parameters have shown signs of excessive foaming. Amount of outlet flash gas from flash drum after absorber tower was high and opening of LV0026 (bottom absorber level valve) a sign of flash gas was increased, too. This is clearly shown below (fig.4).

Figure 4- Flash gas form flash drum and LV0026 opening

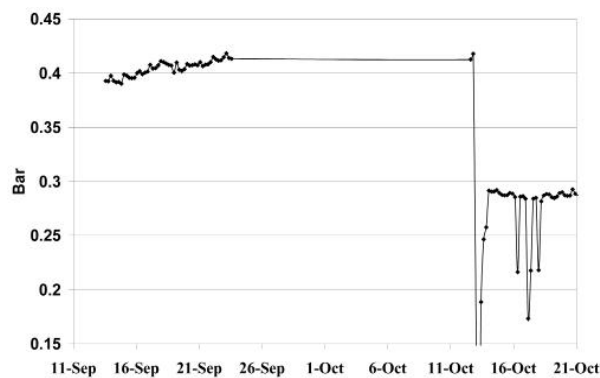
Before 2009 overhaul absorber DP in gas train was increasing gradually and caused amine carry over from absorber to treated gas K.O drum. This means there is foaming in absorber. Therefore, to prevent risk of tray failure, feed to absorber was reduced in order to meet max allowable DP across the tower. During overhaul lots of scale was found over trays. After overhaul opening of LV0036 (bottom sweet gas K.O drum level valve) a sign of carryover and PDI-0026 (Absorber DP) decreased (fig 5, 6). LV0036 opening reduction shows that amine carryover was reduced after overhaul. These indicate foaming has reduced in amine loop. DP reduction can be related to the cleaning of scales over the tower trays, too. DP of absorber before overhaul reached 0.41 barg and decreased down to 0.28 barg after overhaul and tray cleaning.

Figure 5- DP of amine absorber

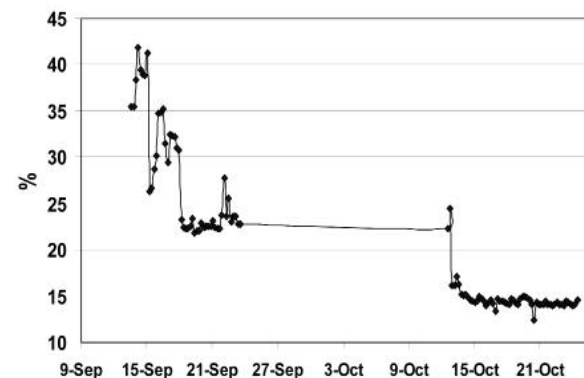
Figure 6- Bottom sweet gas K.O drum level valve

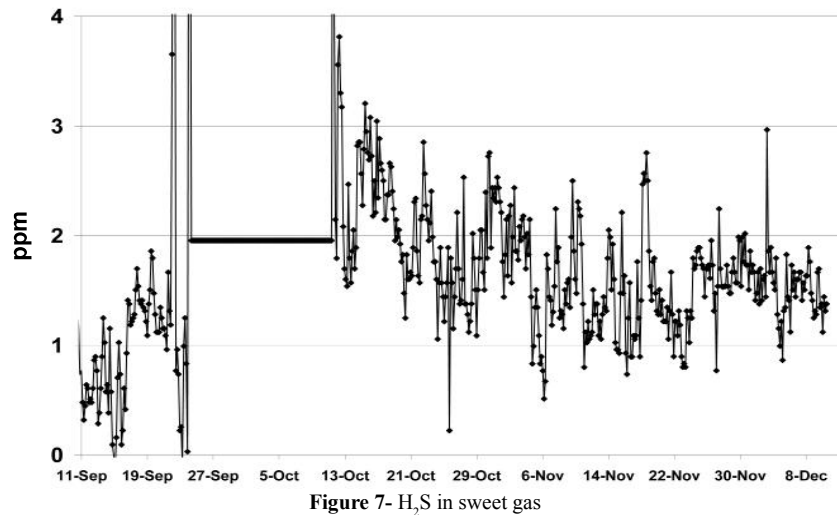
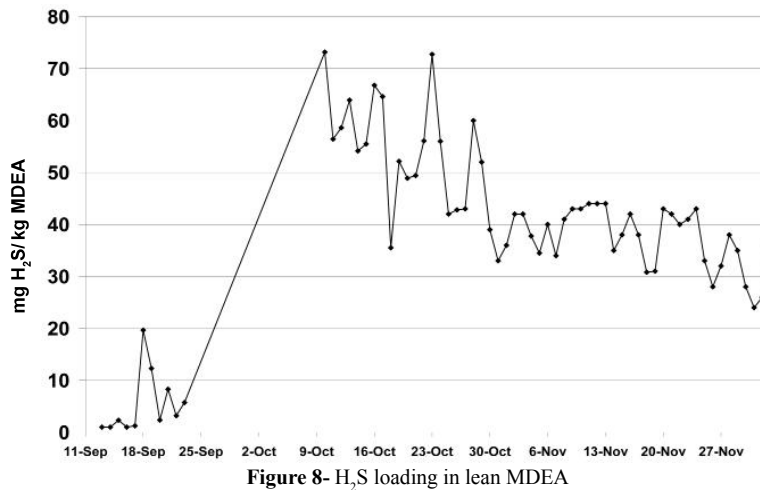
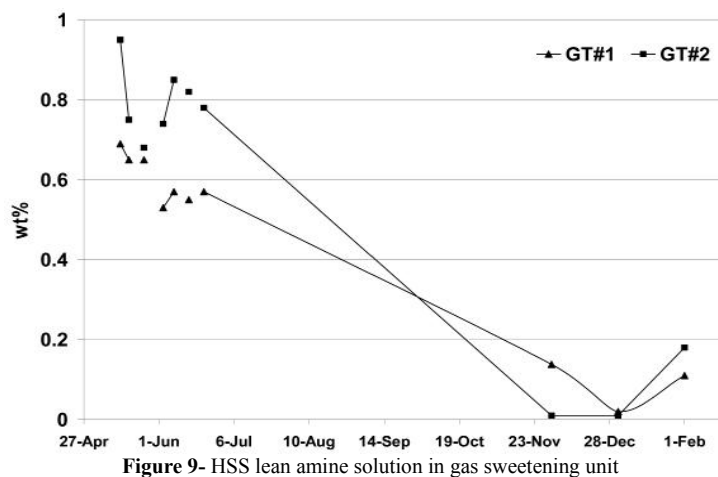
H₂S content of sweet gas was within acceptable range before amine replacement, but it was high after MDEA replacing because H₂S loading of fresh MDEA was considerably higher than that of old MDEA as a result of acid assisted regeneration phenomena. By taking some actions, such regeneration, top temp increasing and amine flow decreasing, sweet gas H₂S content dropped back to the spec range (fig7).

After start up of the H₂S unit loading of the lean fresh MDEA was considerably higher than old MDEA while all operating parameters were the same as before (Fig.8).

This is a problem many plants have experienced after amine replacing. What is happening is a result of loss of heat stable salts in old amine solution. Actually, the acids that make these salts improve the regeneration of the MDEA because they will preferentially drive off the H₂S from the lean amine solution, leading to a lower lean loading than it would get with pure MDEA. This phenomenon is known as "acid assisted regeneration". (fig.9).

Another reason for high H₂S loading can be higher loading CO₂ by fresh amine, which can affect the regenerator tower performance and lead to increased H₂S loading. As the fresh amine begins to form heat stable amine salts, solvent starts to reach lower and lower lean loadings for the same regeneration conditions. It should just let natural incursion rate of salts solve the problem.

However, there are some actions that have been taken to decrease amine H₂S loading. These actions are:

1. Decreasing amine flow rate from 155 down to 140 m³/h in order to increase MDEA residence time in regenerator.
2. Increasing regenerator top temperature set point from 98 to 105 °C in order to have better amine regeneration and H₂S loading decrease.

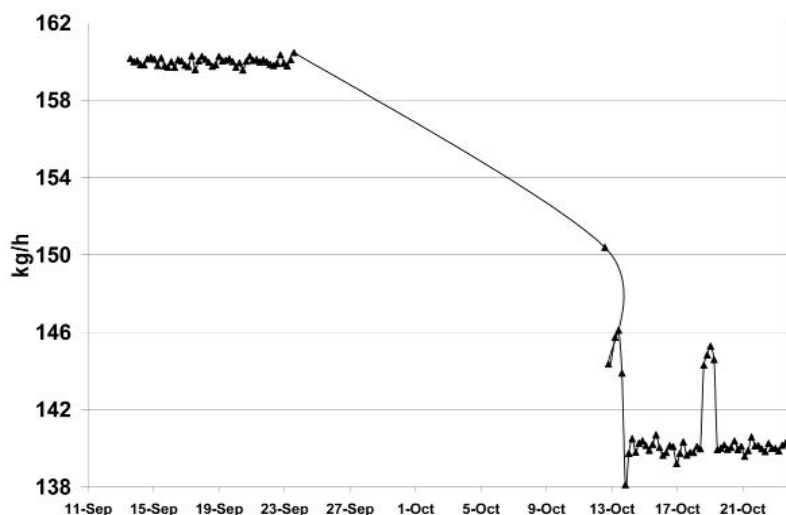
As we know, the higher the temperature, the higher the amine degradation rate. As mentioned above, amine flow rate was decreased. If amine flow rate is lower, it can provide suitable regeneration temperature with lower regenerator bottom temperature. In conclusion, by taking these actions, amine degradation due to more regeneration temp is reduced. So, amine flow rate was declined after amine replacing (see fig10).

Figure 10- Amine flow rate in gas sweetening unit

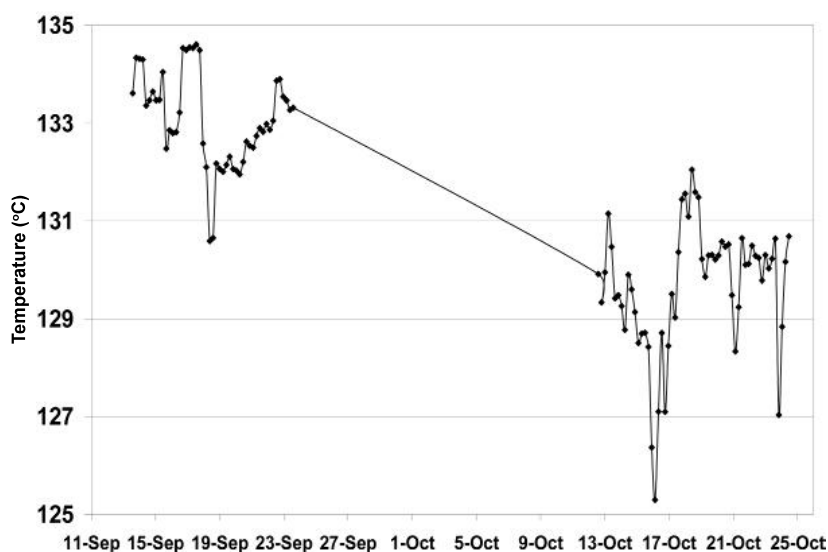
In order to prevent formation of primary or secondary amine in MDEA solution, the reboiler temperature shall not rise above 132 °C even for a short time [7], while according to the trends of reboiler temperature, this value exceeds frequently before amine replacement. This high temperature could be due to the presence of MEG in amine loop. This event is very harmful. Because high temperature can cause amine degradation leading to acid causing corrosion. In fact, heat stable salts are formed when amines react with acidic components other than H_2S and CO_2 in the inlet gas to the amine absorber. According to the amine expert documents this problem can occur when the salt stability decreases in the point where some disassociations take place in a site- specific location in the unit. Corrosion occurs when that disassociation creates a corrosion cell with metal in the system. Other problems are caused by chelating effect of some of the organic acids, which are formed. They can hold the iron in solution rather than allowing it to form a protec-

tive film on the metal, resulting in areas of fresh metal where corrosion is more likely [8]. As mentioned, to decrease amine H_2S loading, regenerator top temperature is increased from 98 to 110°C to improve amine regeneration. However, top temperature increase aligns with bottom temperature increase. In order to prevent formation of primary or secondary amine in MDEA solution, the reboiler temperature shall not rise above 132°C because this high temperature leads to amine degradation. Amine degradation products (results of chemical modification of alkanolamines) promote corrosion by complexing iron. That complex iron enhances the corrosion in amine systems in the same manner as HSS. Regenerator bottom temperature is kept below 132°C by amine flow reducing from 155 to 140 m^3/h . Lower amine flow rate increases MDEA residence time in regeneration loop and as a result decreases H_2S loading so that it could be possible to decrease top temperature from 110 to 105°C and consequently bottom temperature to less than 132°C in order to prevent degradation.

Figure 11- Bottom regenerator temperature in gas sweetening unit

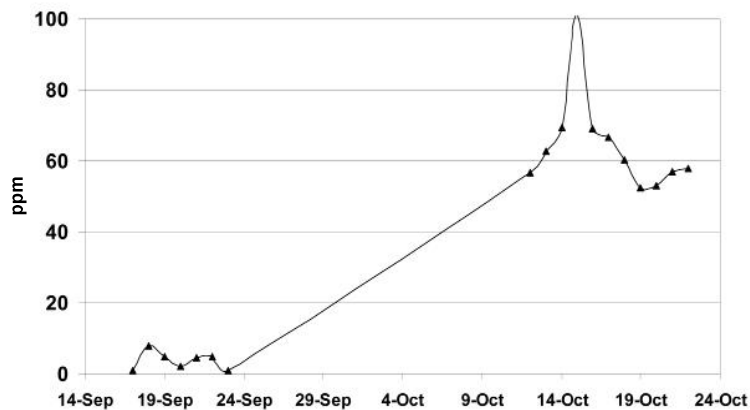
Trends in fig.13 show that Total Suspended Solid (TSS) has been increased after shut down and amine replacement. Because during overhaul cleaning and washing of gas sweetening unit equipments and piping were not done due to time limitation. It's recommended to perform washing before loading new amine and put amine filtration packages in service before gas sweetening unit start up.

Figure 13- Total suspended solid in lean MDEA
